Niagara Falls Boulevard
Pedestrian Road Safety Audit
Ridge Lea Road to East Robinson Road
Town of Tonawanda and Town of Amherst
June 25, 2018

This report provides a summary of observations recorded using prompt lists from the Federal Highway Administration [Pedestrian Road Safety Audit \(RSA\) Guidelines and Prompts List](#), J FHWA-SA-07-007, July 2007. The form of observations were recorded using a GIS mobile application developed the Town Engineering Departments. The walk audit was conducted on Monday, June 25, 2018 by the assembled RSA team

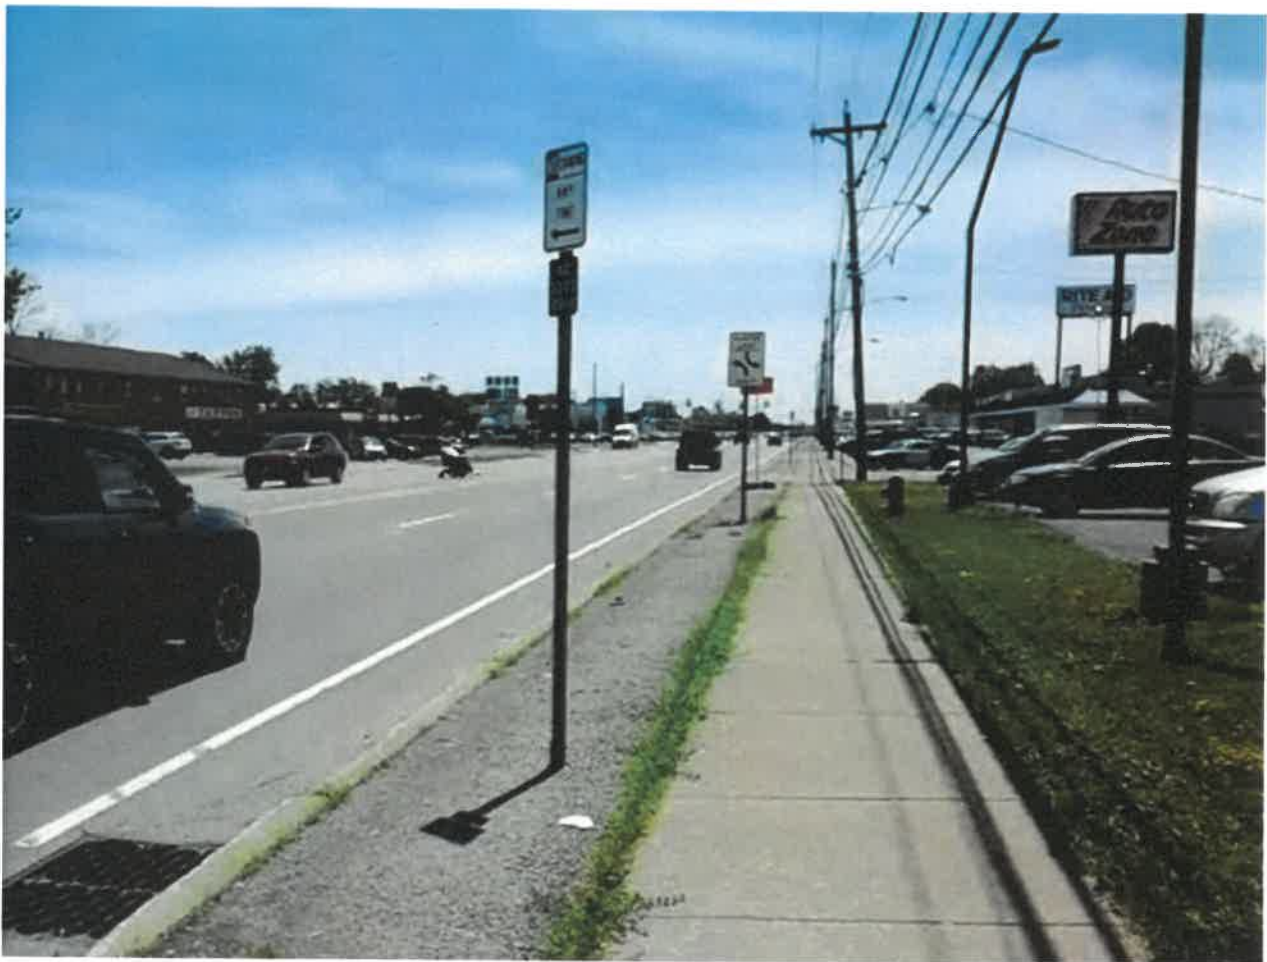
Figure 1 Wheelchair pedestrian crossing south of Roger Chaffee Dr. 6/25/2018

One pedestrian fatality and three injury crashes are reported in this segment. Two of the injury and the fatality crashes were noted at the Thistle/Roger Chaffee intersection. Note: report cover photo is approximately 100 feet south of this intersection.

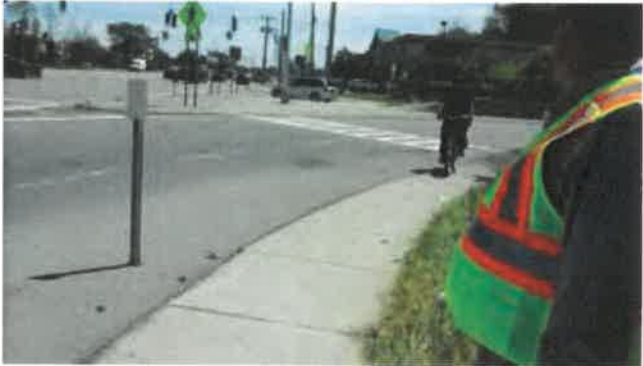
Bicyclists were observed using sidewalks as no significant bicycle accommodations are provided on the road (Figure 2a).

Figure 2a Bicyclist at I-290 EB On Ramp

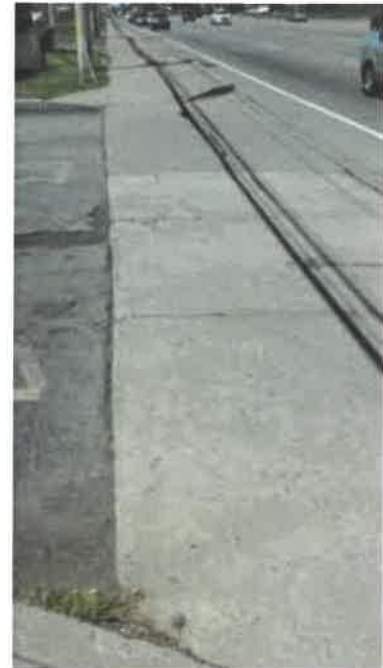
Home Depot driveway to Faragut Avenue/Draden Lane – Figure 4

There are no crosswalks on the south legs at Greenhaven Terrace and Home Depot driveway to cross the Boulevard. The exclusive north bound right turn lane into the Home Depot driveway increases crossing distance by 15% across the 100 feet of pavement. There are no raised medians to provide pedestrian refuge at the intersection, particularly at the east leg of the intersection where a raised median exists but does not extend into the existing crosswalk. ADA devices are improperly located.

Transit stops do not have shelter nor seating. Two northbound and two southbound bus stops exist in this segment. Loading areas and surfaces are substandard.

One pedestrian fatality and four injury crashes are reported in this segment three of which were reported at the Greenhaven Terrace intersection.

Smaller commercial/retail businesses occur on the both sides of the corridor within this segment however the lots on the east side have longer, parallel frontages and includes a large auto dealership car storage lot. Several walking surface deficiencies were noted included utility patches, excessive vertical deflections (Figure 4a) and substandard surfaces.

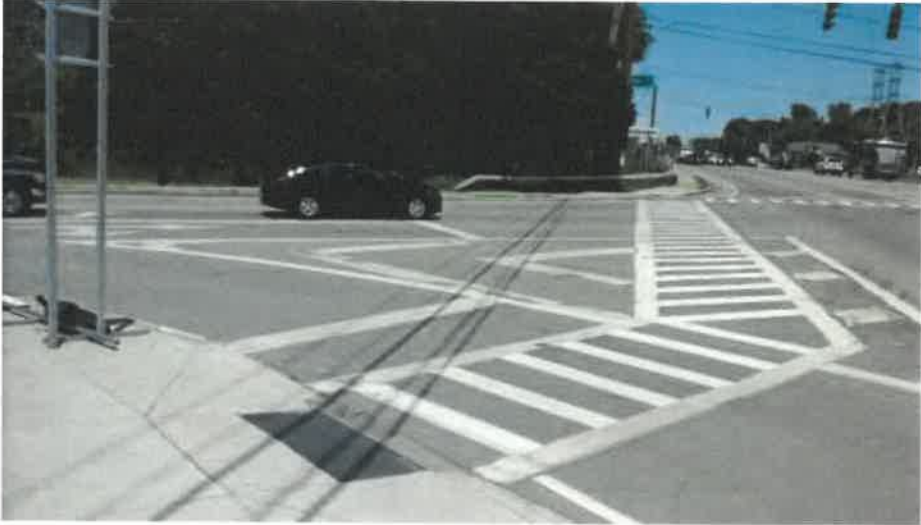
Figure 6a Eastbound South Ellicott Creek Road

The eastbound right turn slip ramp increases pedestrian crossing distance and does not provide pedestrian refuge. The eastbound approach is at a 30° skew from perpendicular (Figure 6a). There is no crosswalk on the south leg of either Ellicott Creek road intersections. ADA push buttons and detectable warning plates are improperly located or missing.

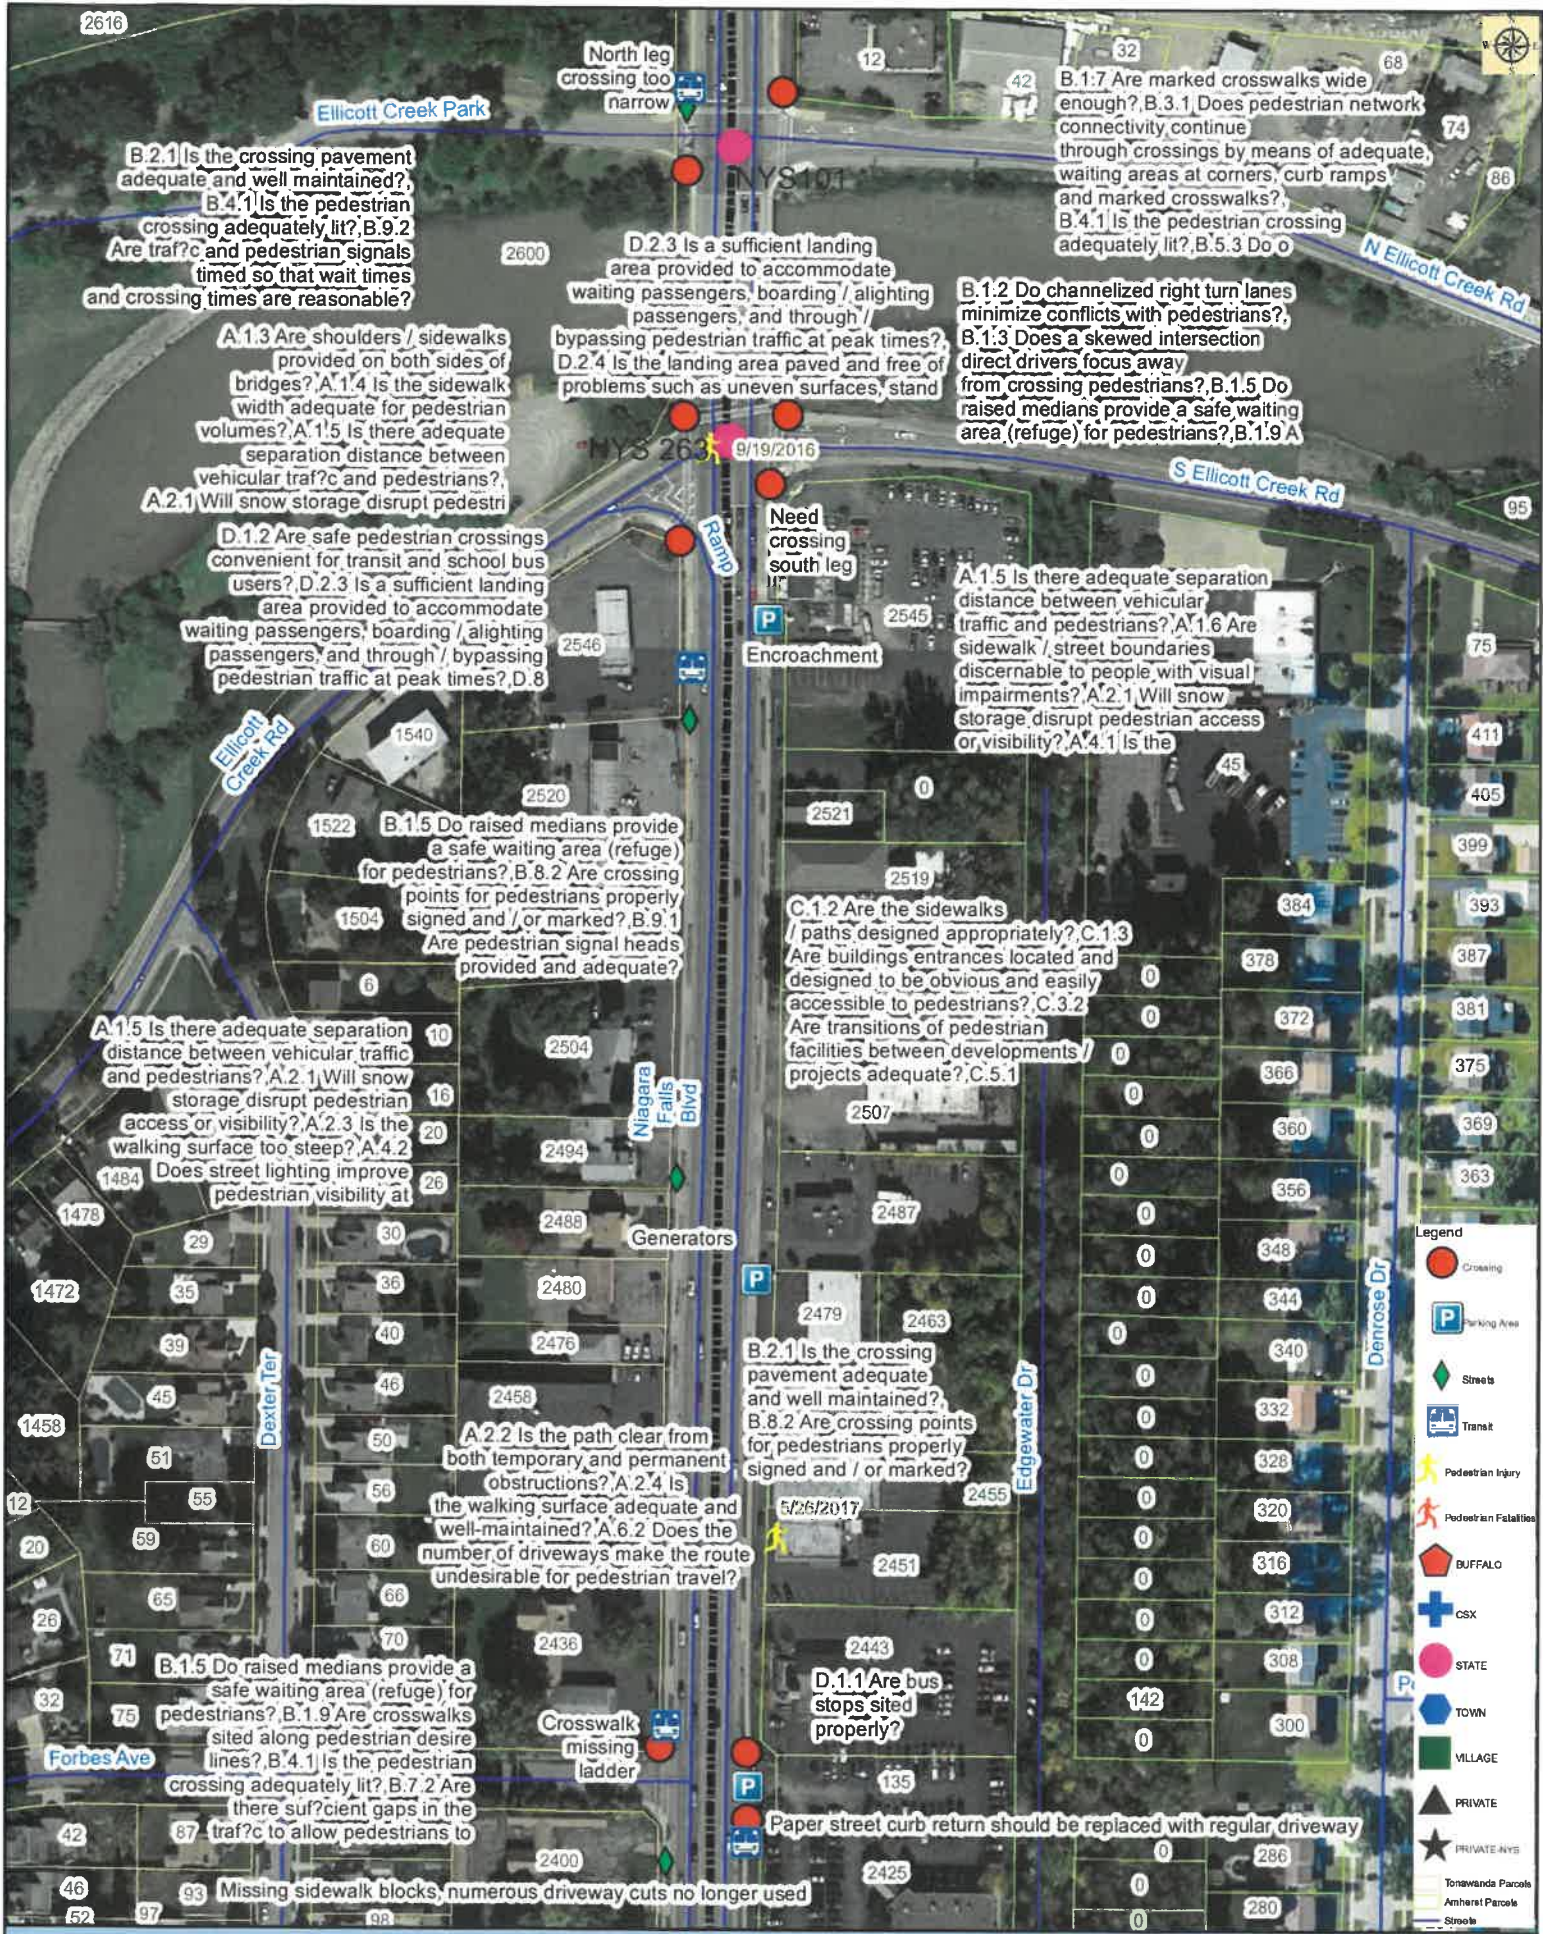
Figure 6
 Forbes Avenue to North Ellicott Road

Parking lots were noted to be paved right to the back edge of sidewalks, typical along the study corridor. This effects adequate pedestrian buffer from parked vehicles and snow storage. A sidewalk encroachment was noted at the building at 2545 Niagara Falls Boulevard.

The signals at south and north Ellicott Creek Road are 312 feet apart and are interconnected to avoid queuing into each other’s intersections during left turn phases from Ellicott Creek roads. Northbound and southbound left turn only phases get called without detection which increase overall cycle length and pedestrian crossing wait times.

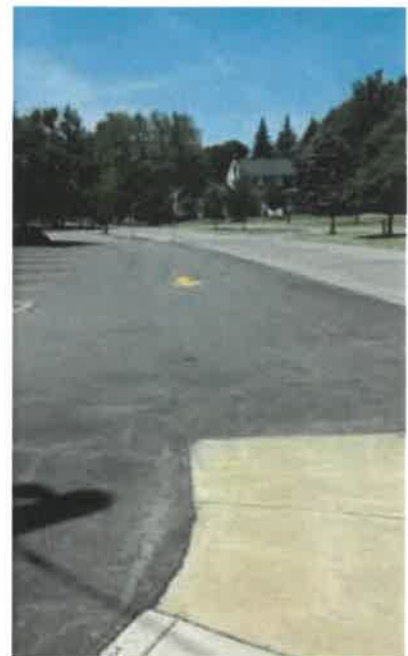
Figure 7a South side of Irvington Drive

Bicycles were observed on the sidewalk. There are no sidewalks on Irwin Road nor Hennepin Road and sidewalk is missing on the south side of Irvington Drive (Figure 7a).

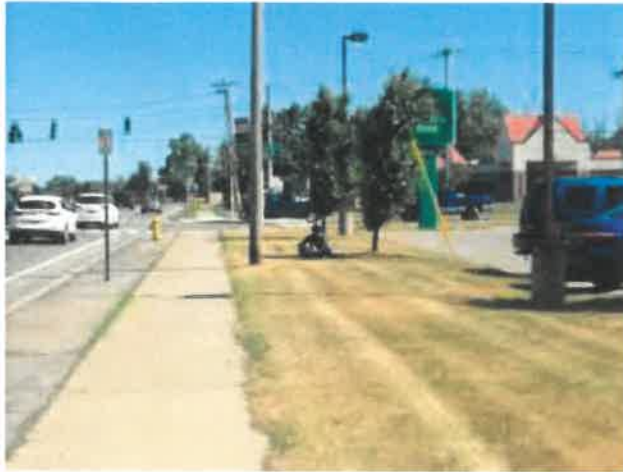
Figure 8a Northbound Transit Stop at Creekside Dr.

of the intersection of Creekside Drive. Transit stops do not have shelter nor seating (Figure 8a). Loading areas and surfaces are substandard.

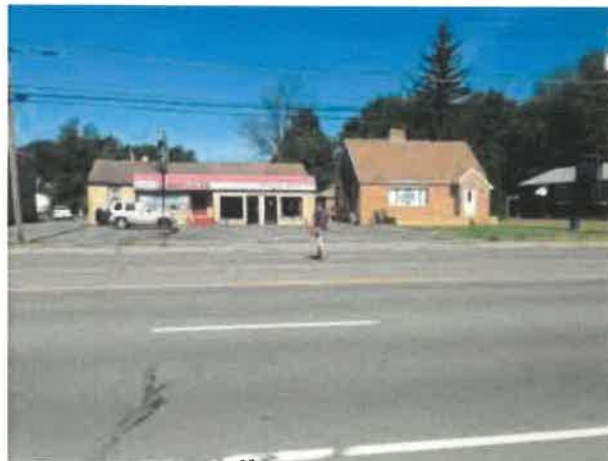
Figure 11 Pedestrian crossing midblock north of Forbes Ave.
